A MID-CENTURY GEM GOES NET POSITIVE

Loom House

Building Enclosure Science and Technology

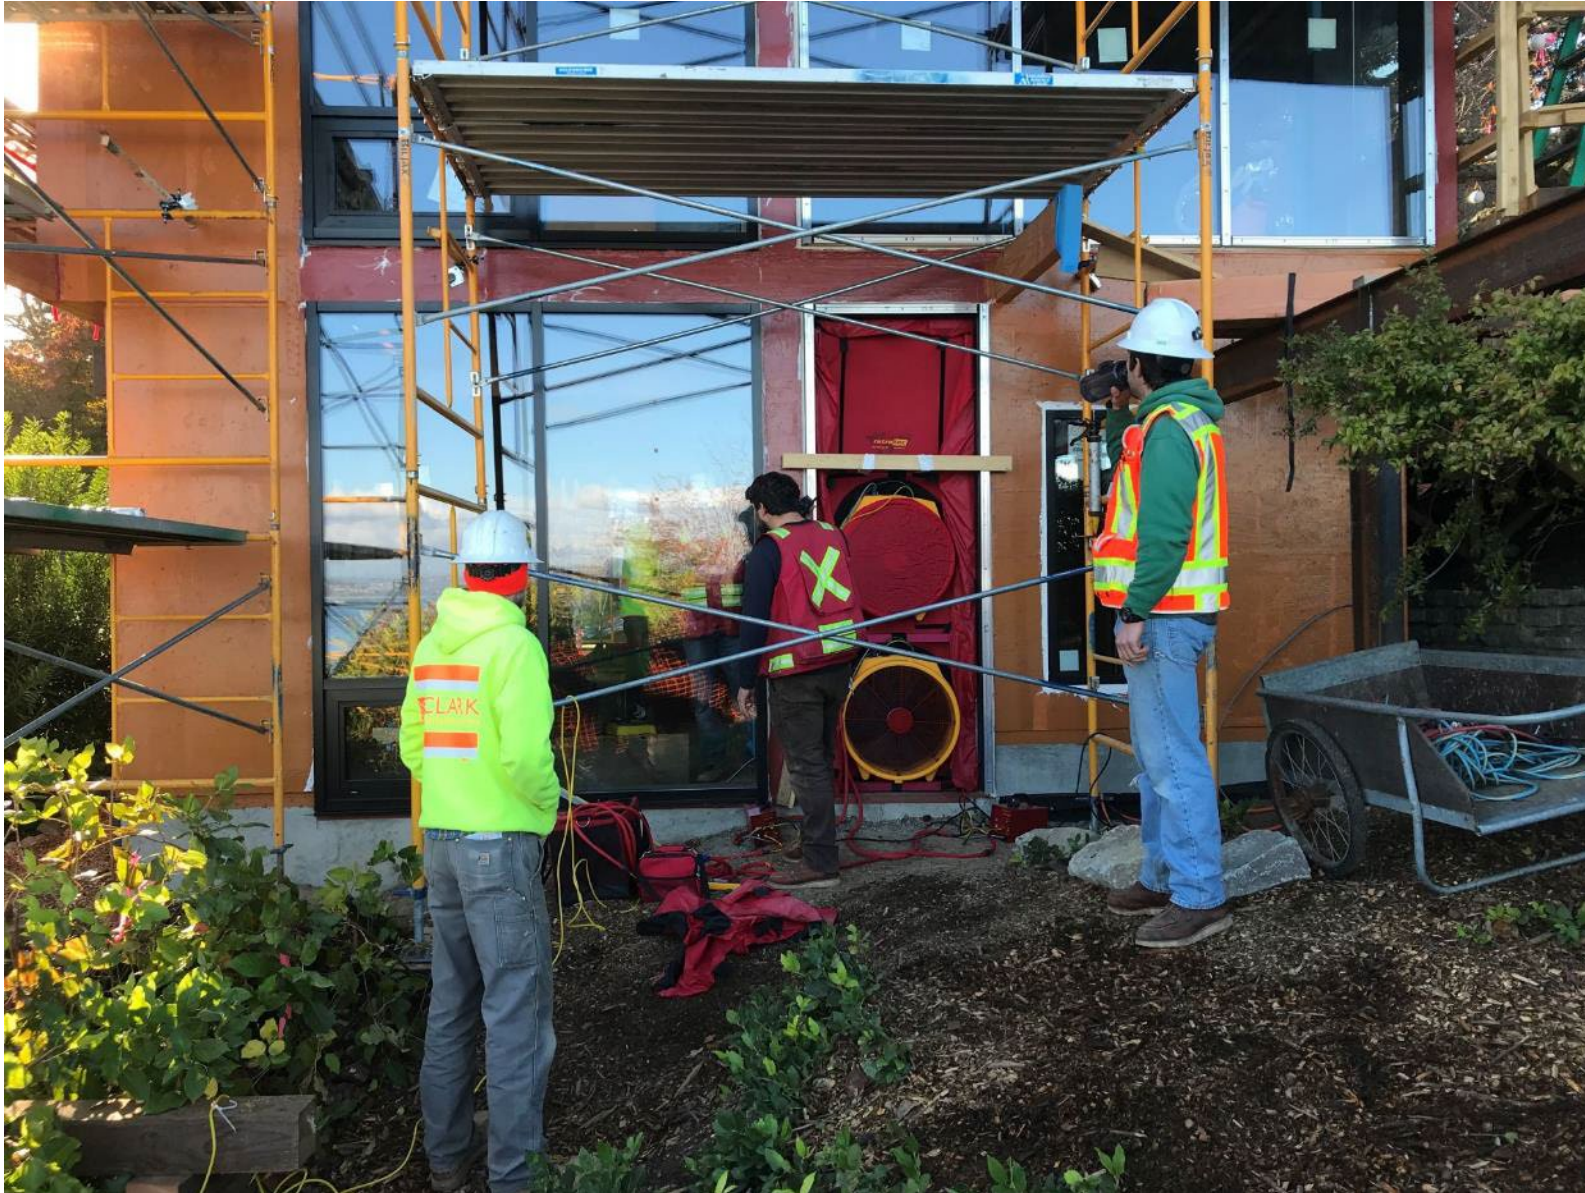
ENVELOPE - INFILTRATION

SOUTH HOUSE

First Blower Door: 0.6 ACH50

Tested after all windows, skylights and fluid applied WRB were installed.
Mechanical exhaust and supply penetrations were not yet completed.

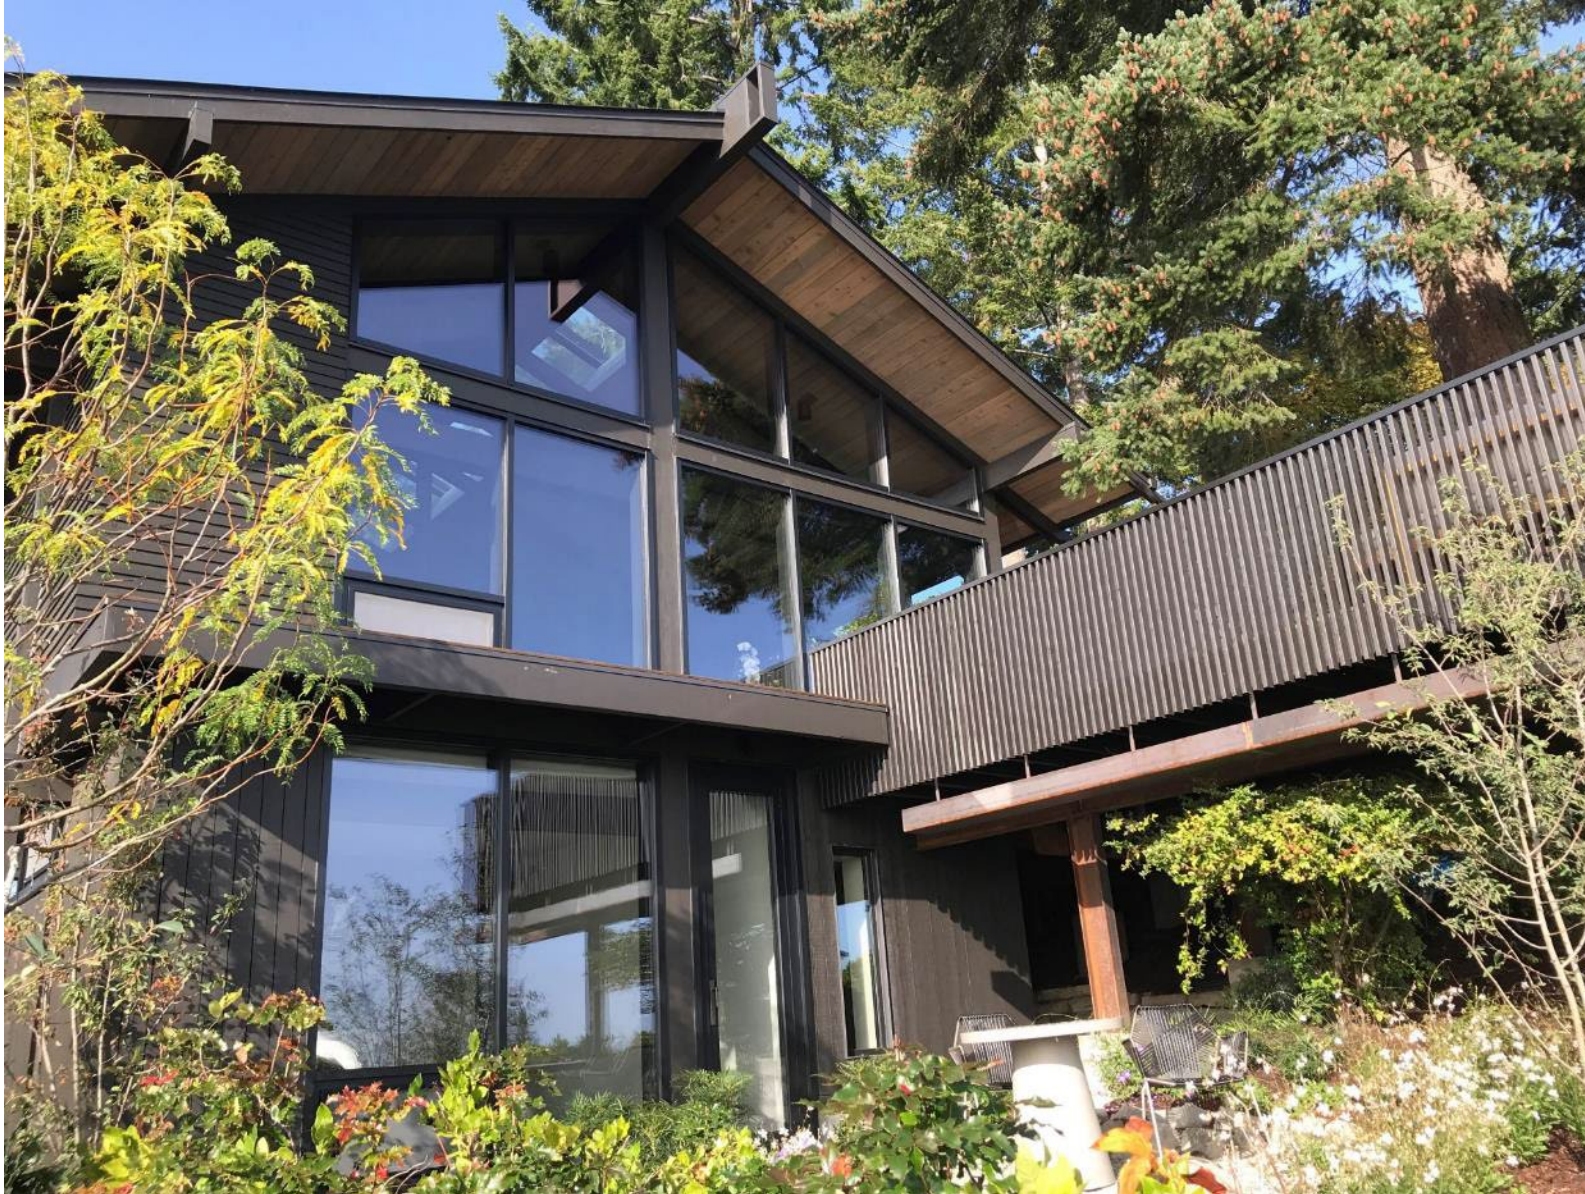
ENVELOPE - INFILTRATION

SOUTH HOUSE

First Blower Door: 0.6 ACH50

Tested after all windows, skylights and fluid applied WRB were installed.
Mechanical exhaust and supply penetrations were not yet completed.

Final: 1.3 ACH50

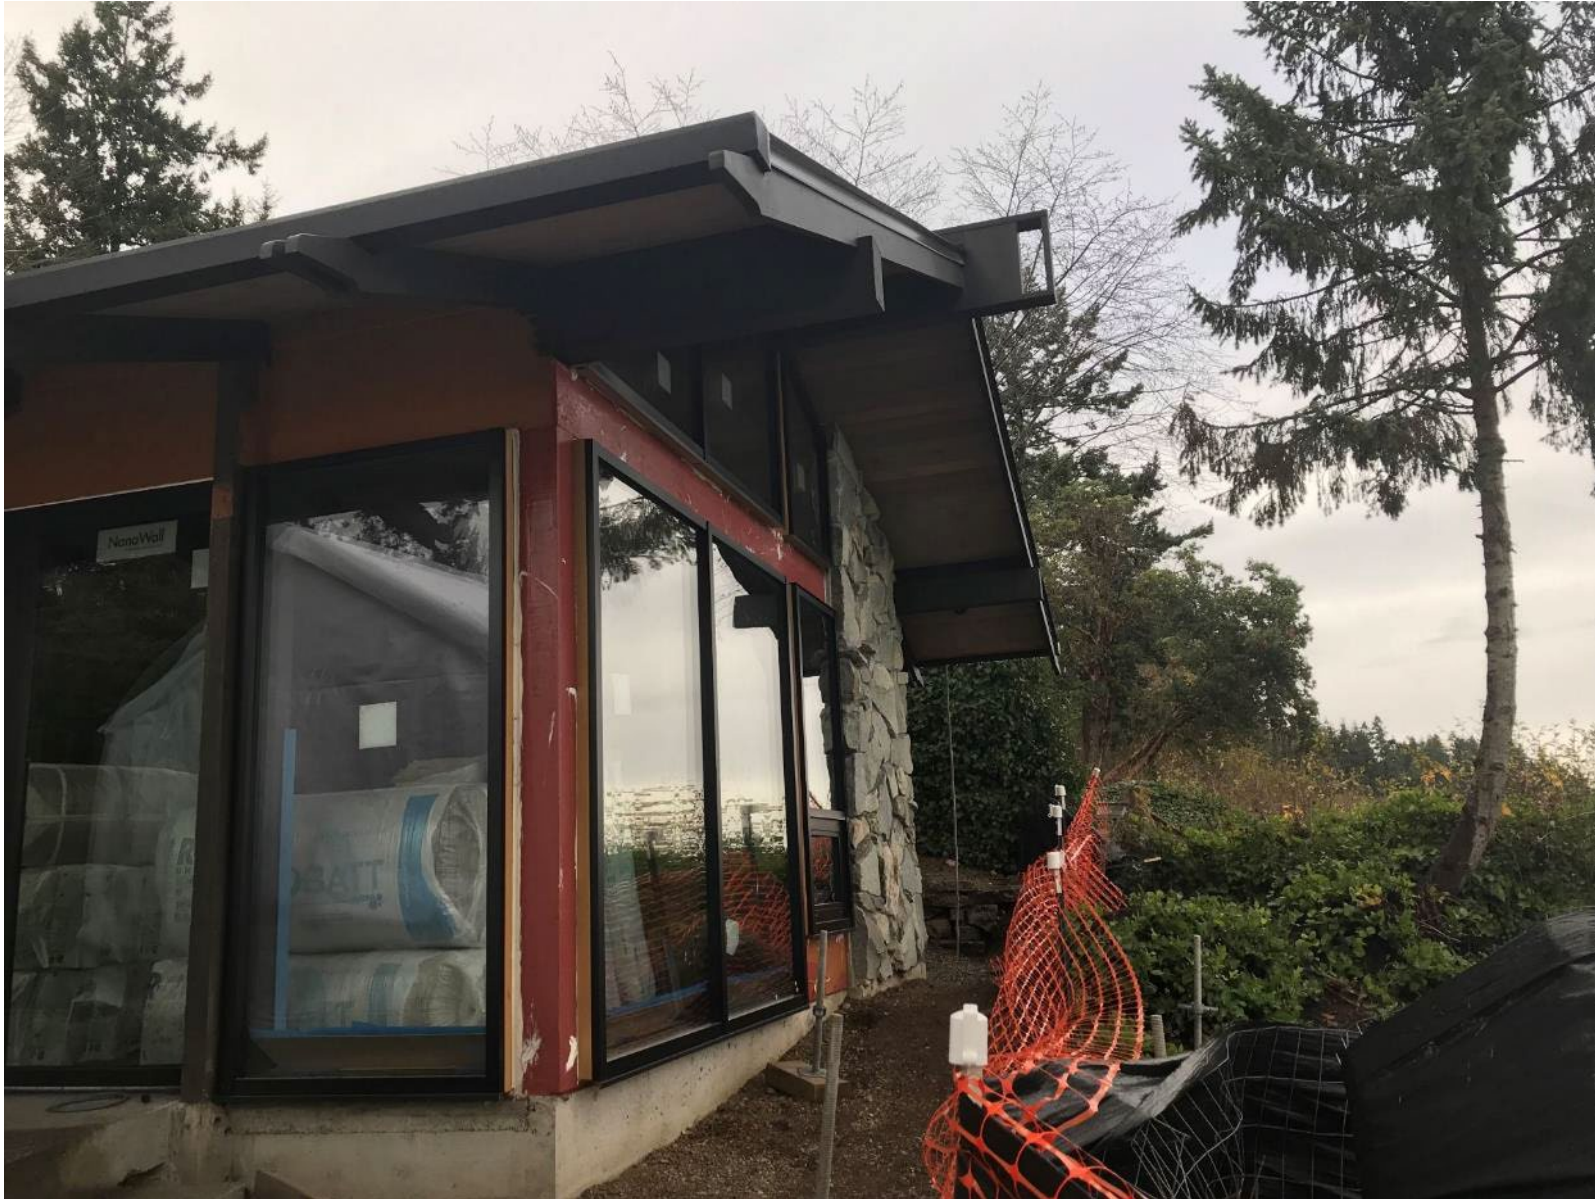
ENVELOPE - INFILTRATION

NORTH HOUSE

First Blower Door: 2.25 ACH50

Tested after all windows, skylights and fluid applied WRB were installed.
Mechanical exhaust and supply penetrations were not yet completed.

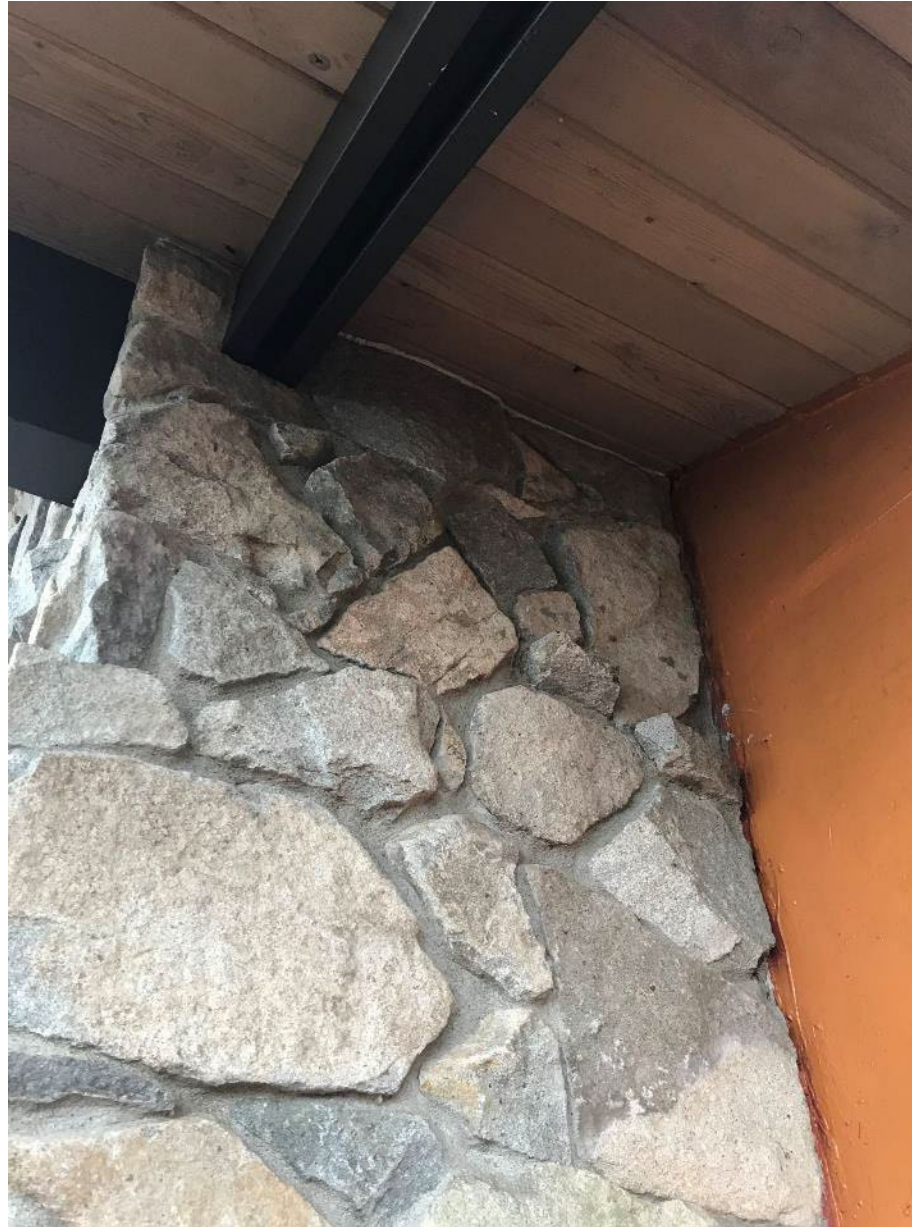
ENVELOPE - INFILTRATION

NORTH HOUSE

Second Blower Door: 2.2 ACH50

Tested again after several gaps at the fireplace and through-wall framing were filled and sealed.

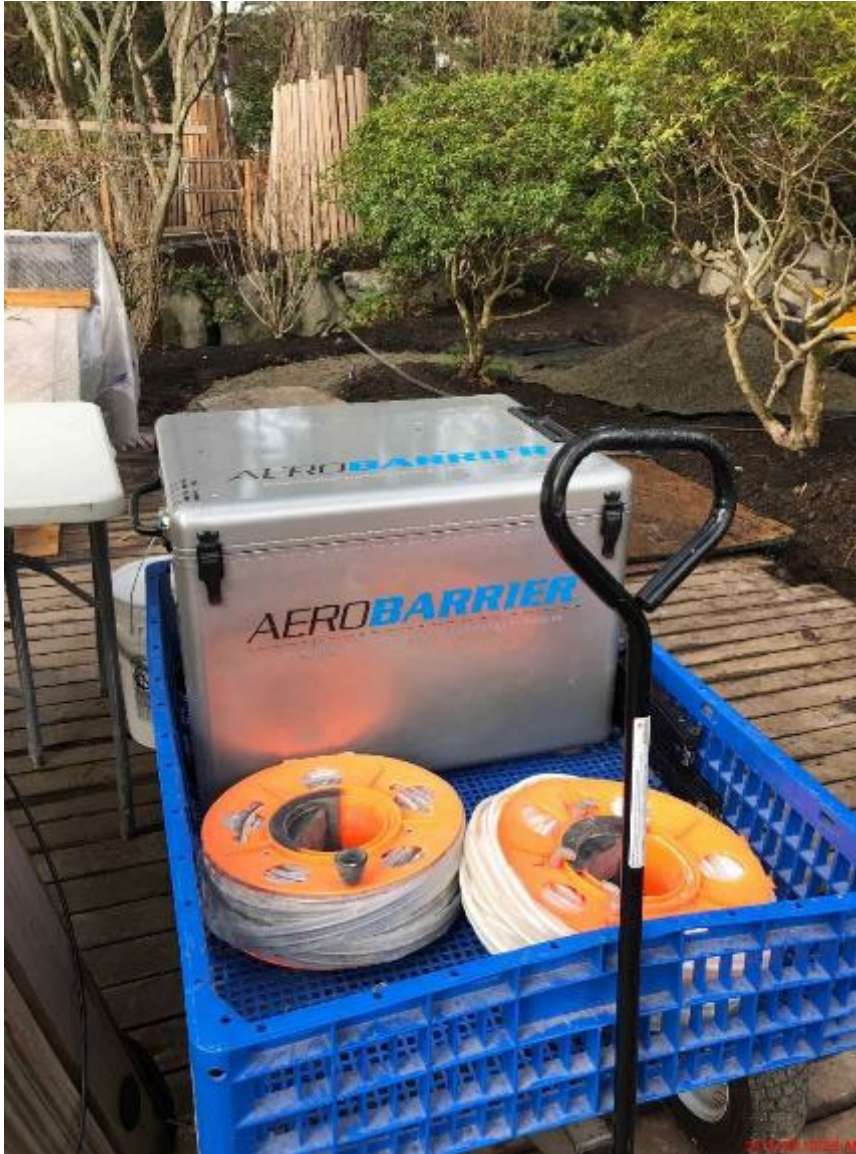
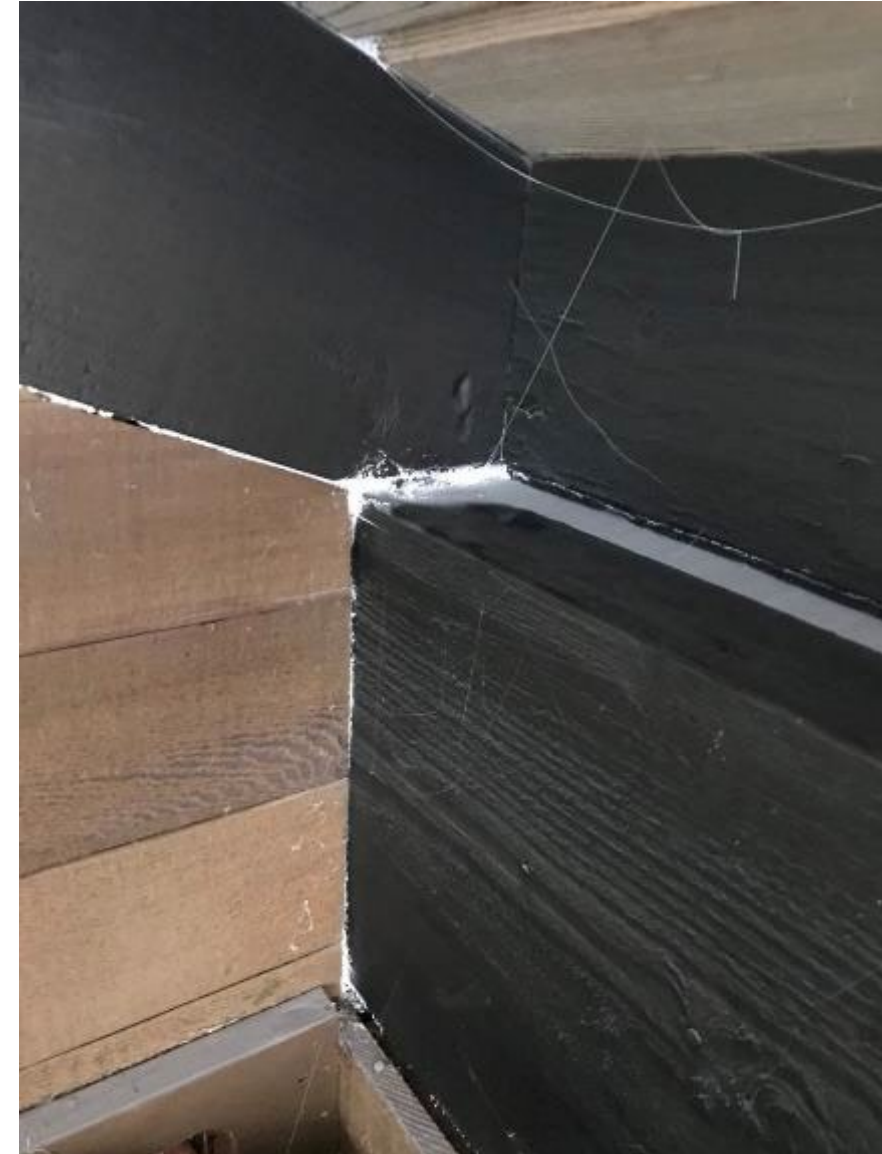
ENVELOPE - INFILTRATION

NORTH HOUSE

Aerobarrier Install: .8 ACH50
(Openings and fireplace was still masked off)

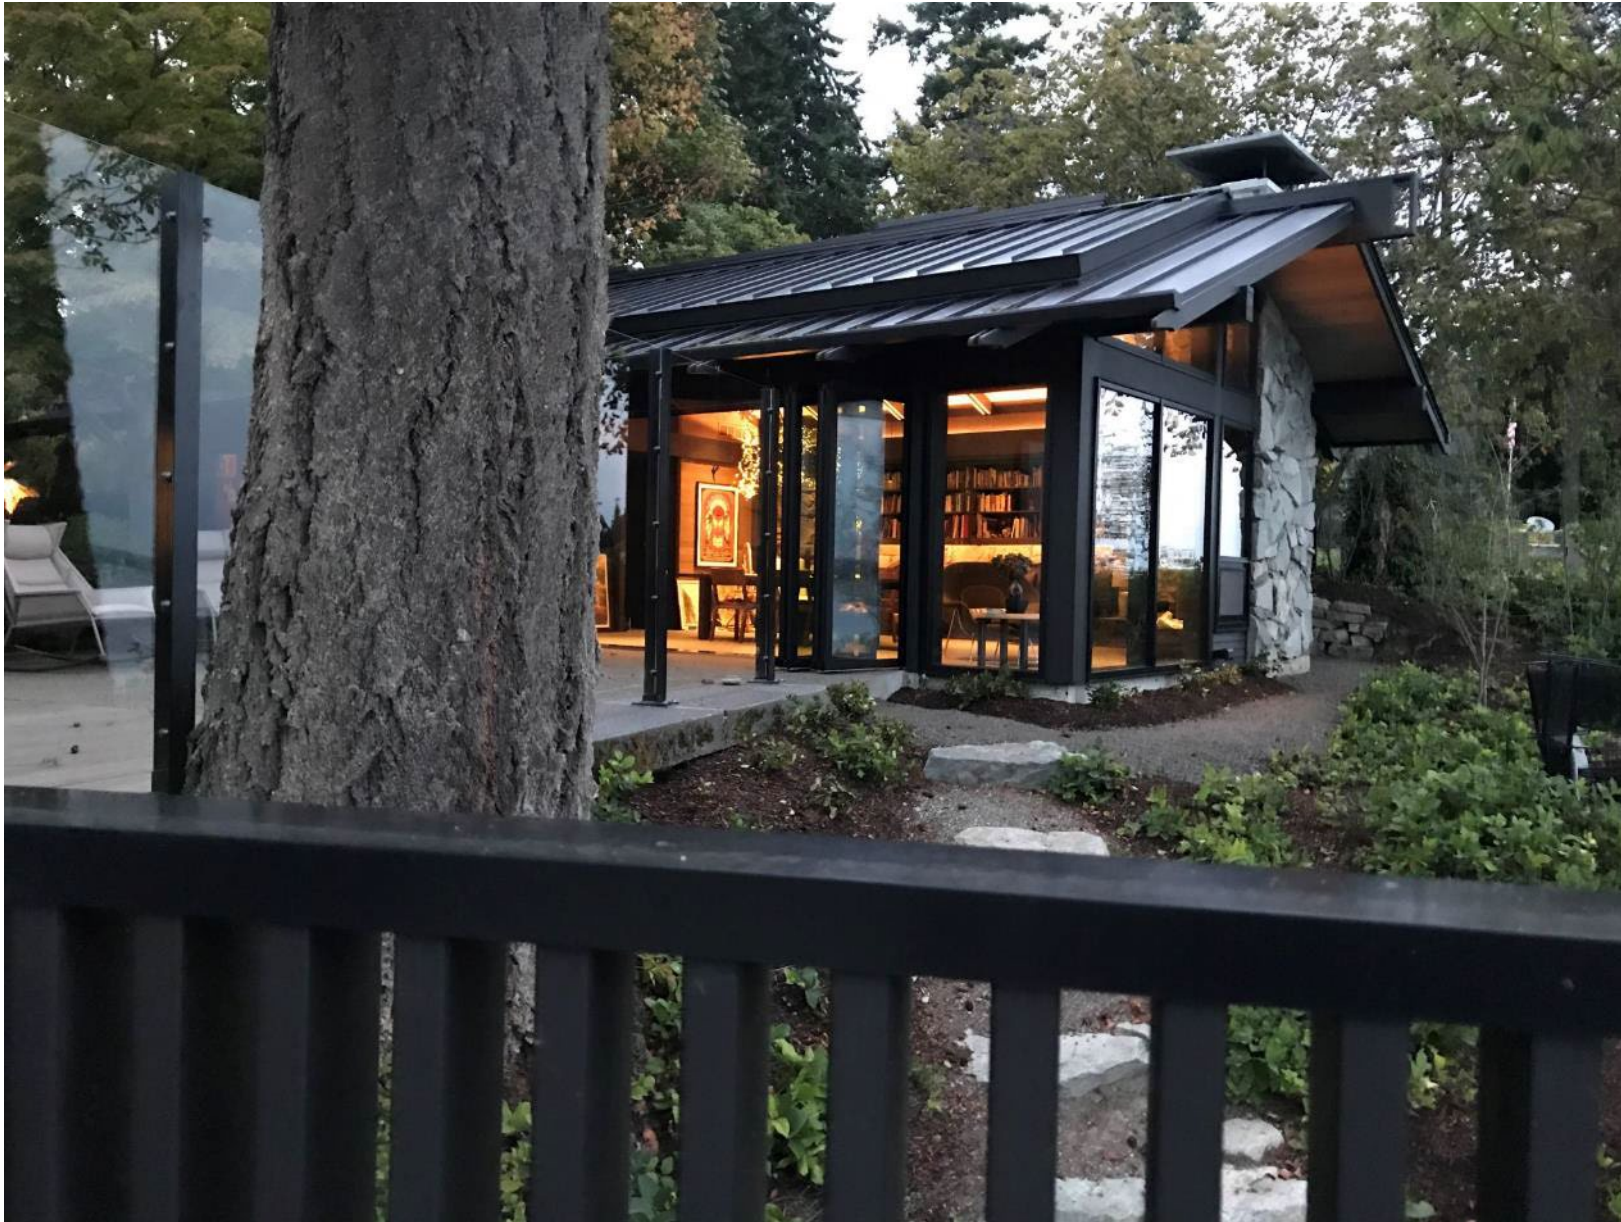
ENVELOPE - INFILTRATION

NORTH HOUSE

Aerobarrier Install: .8 ACH50
(Openings and fireplace was still masked off)

Final Blower Door: 1.8 ACH50

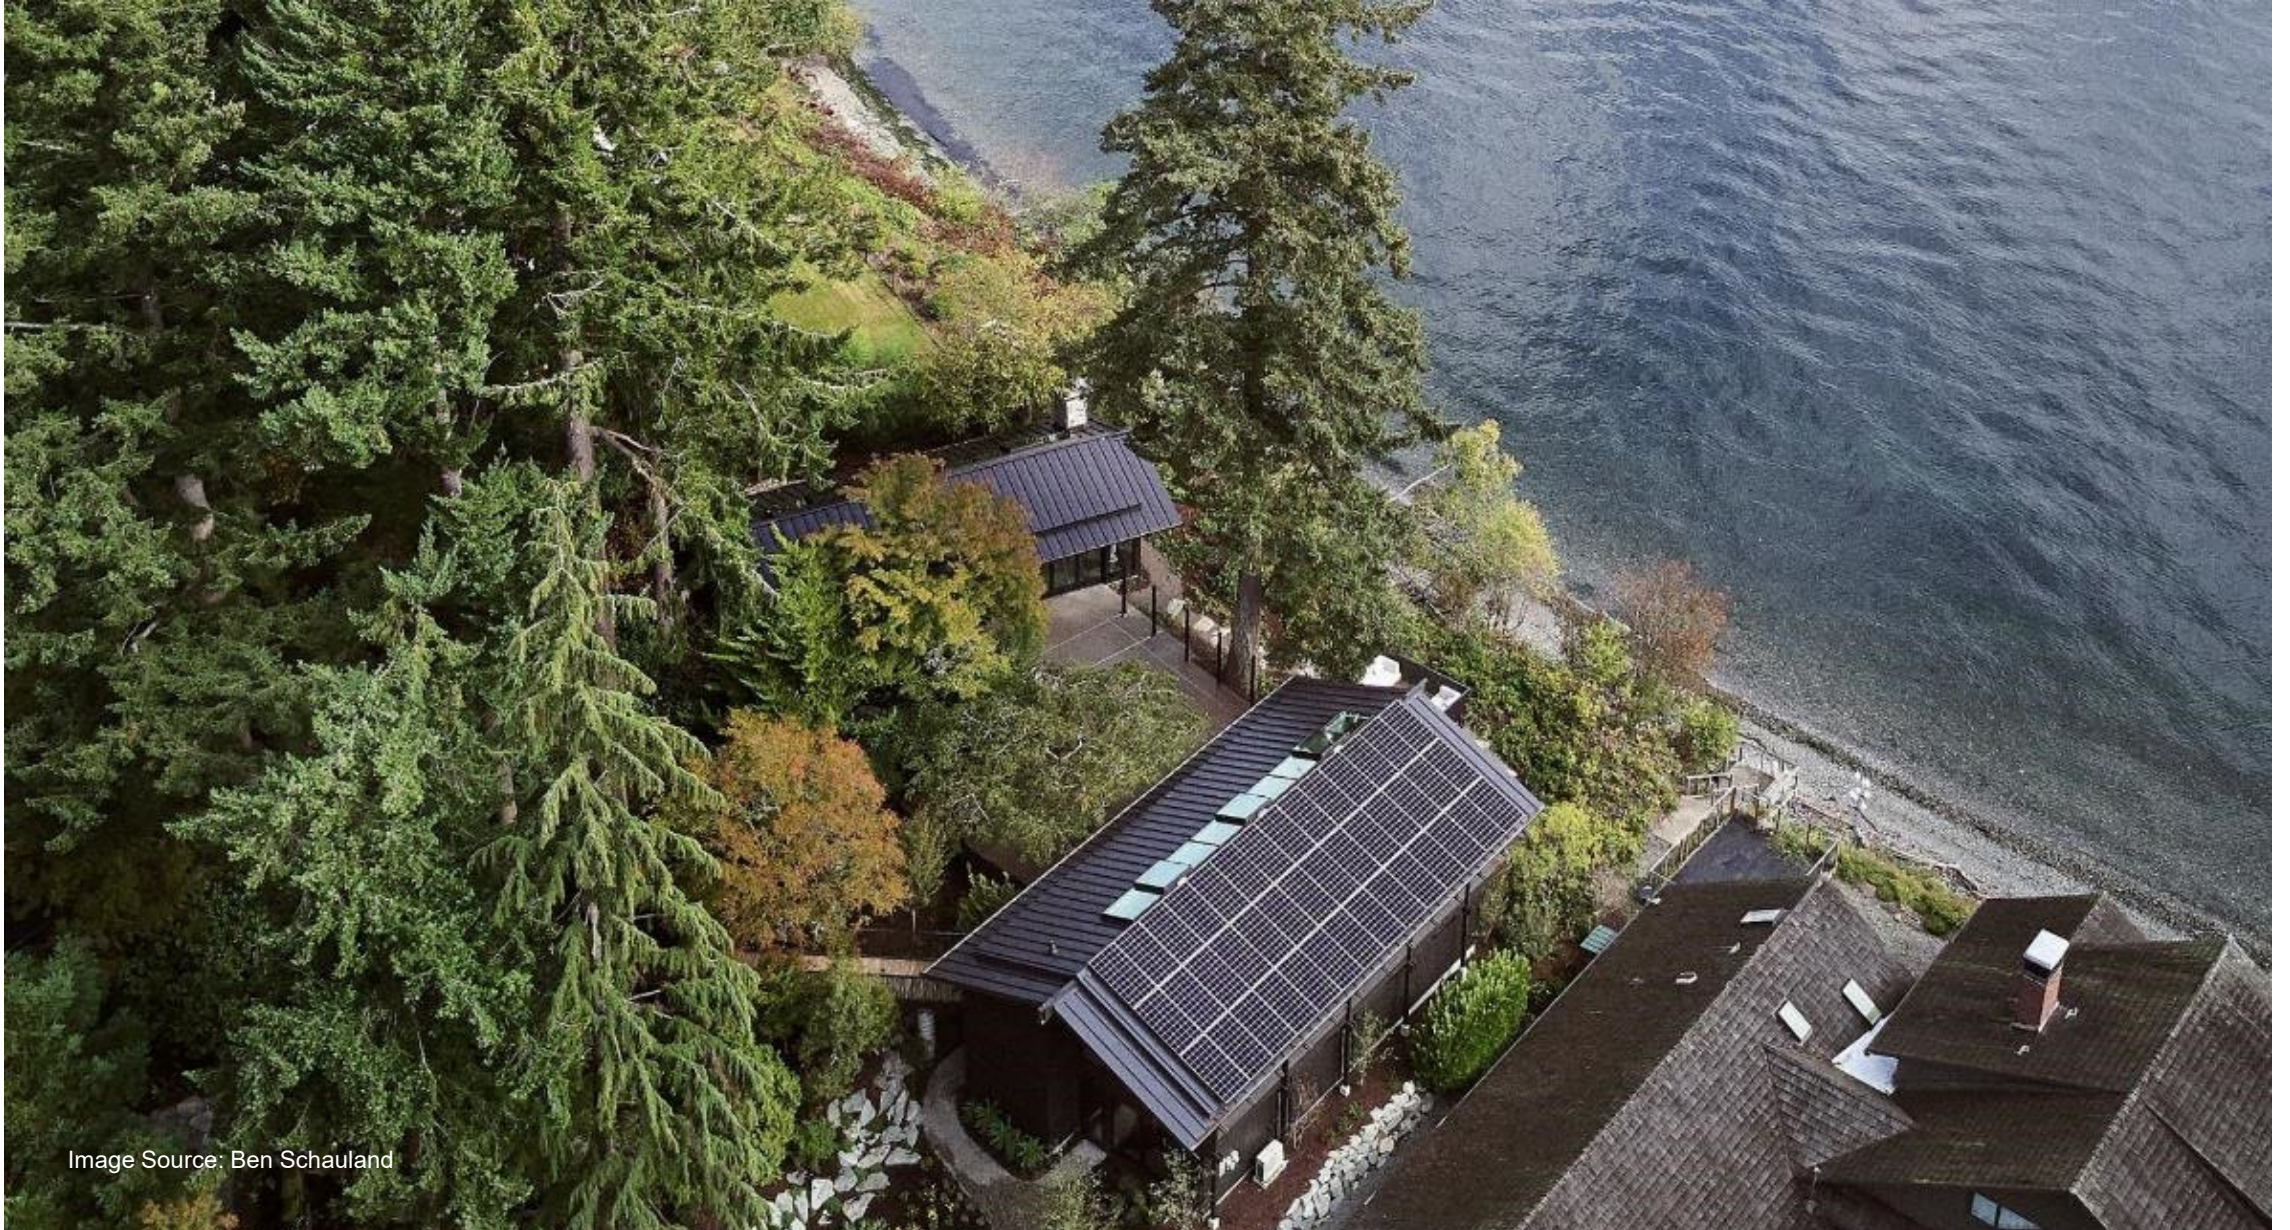
ENERGY — NET POSITIVE ENERGY

NET-POSITIVE ENERGY

Power needs are met by the on-site 16 kW photovoltaic array on the Main House. The array provides 105% of the power usage on site. A backup battery system provides resilience in the event of a power failure.

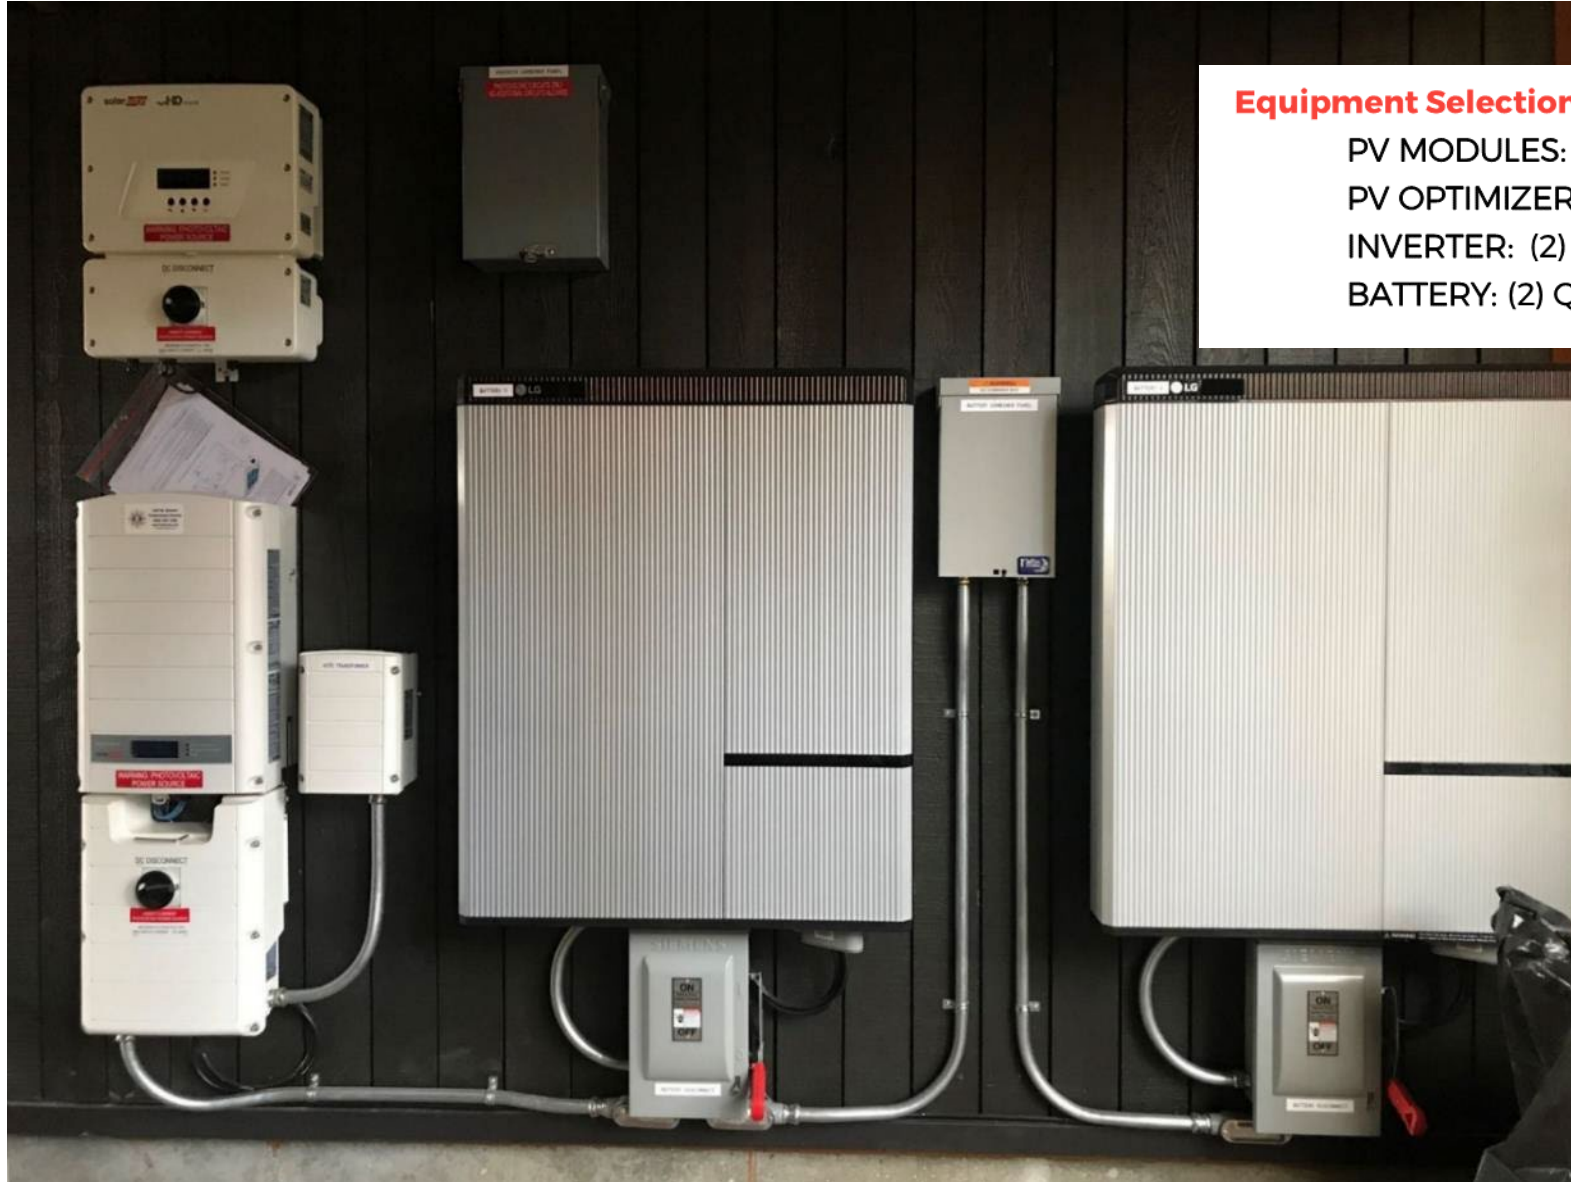
ENERGY – RESILIENCY

Equipment Selections

PV MODULES: (42) Qty. LG 350W NeON R, 14.7kW DC total

PV OPTIMIZER: (42) Qty. SolarEdge P370

INVERTER: (2) Qty. SolarEdge SE7600A-USS

BATTERY: (2) Qty. LG CHEM ESS RESU 10H 9.8kWh

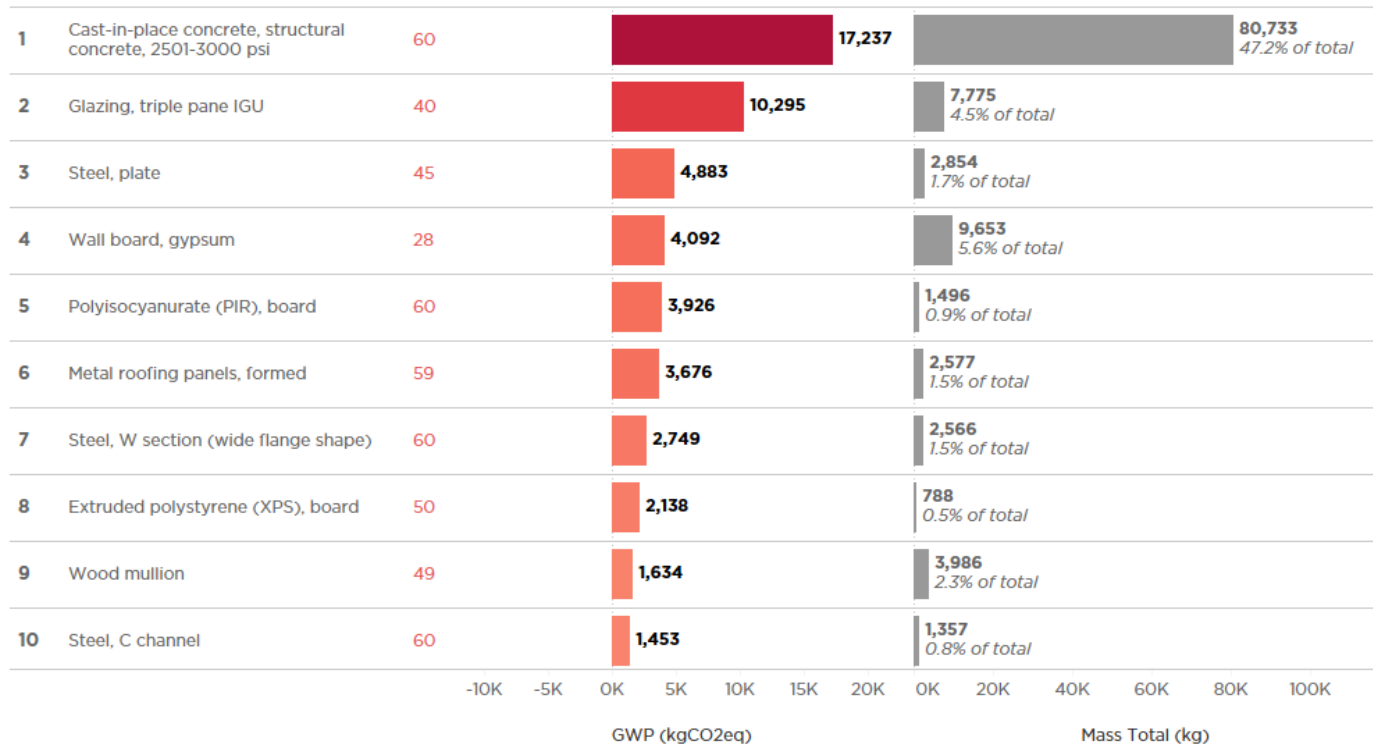
TOP MATERIALS BY GWP (45 materials defined, total)

TOTAL GWP: **43.63 tCO₂e** (9.4 passenger vehicles driving for a year*)
GWP / AREA: **119 kgCO₂e/m²**

Study date: April 27, 2020
Tally modeler: Brie McCarthy
Tally version: 2019.12.21.01
Project area: 3,944 sf
Reference lifespan: 60 years
Design phase: Post-occupancy
Notes: Null
